TR-1248
April 26, 1973

ACCEPTANCE TEST REPORT
(MI-74067-009-00)

SVWS Access Arm, SA 6A
(Serial Number AA-09-03)
(Drawing 75M08129-13)

Boeing Aerospace Company
Atlantic Test Center
KSC, Florida

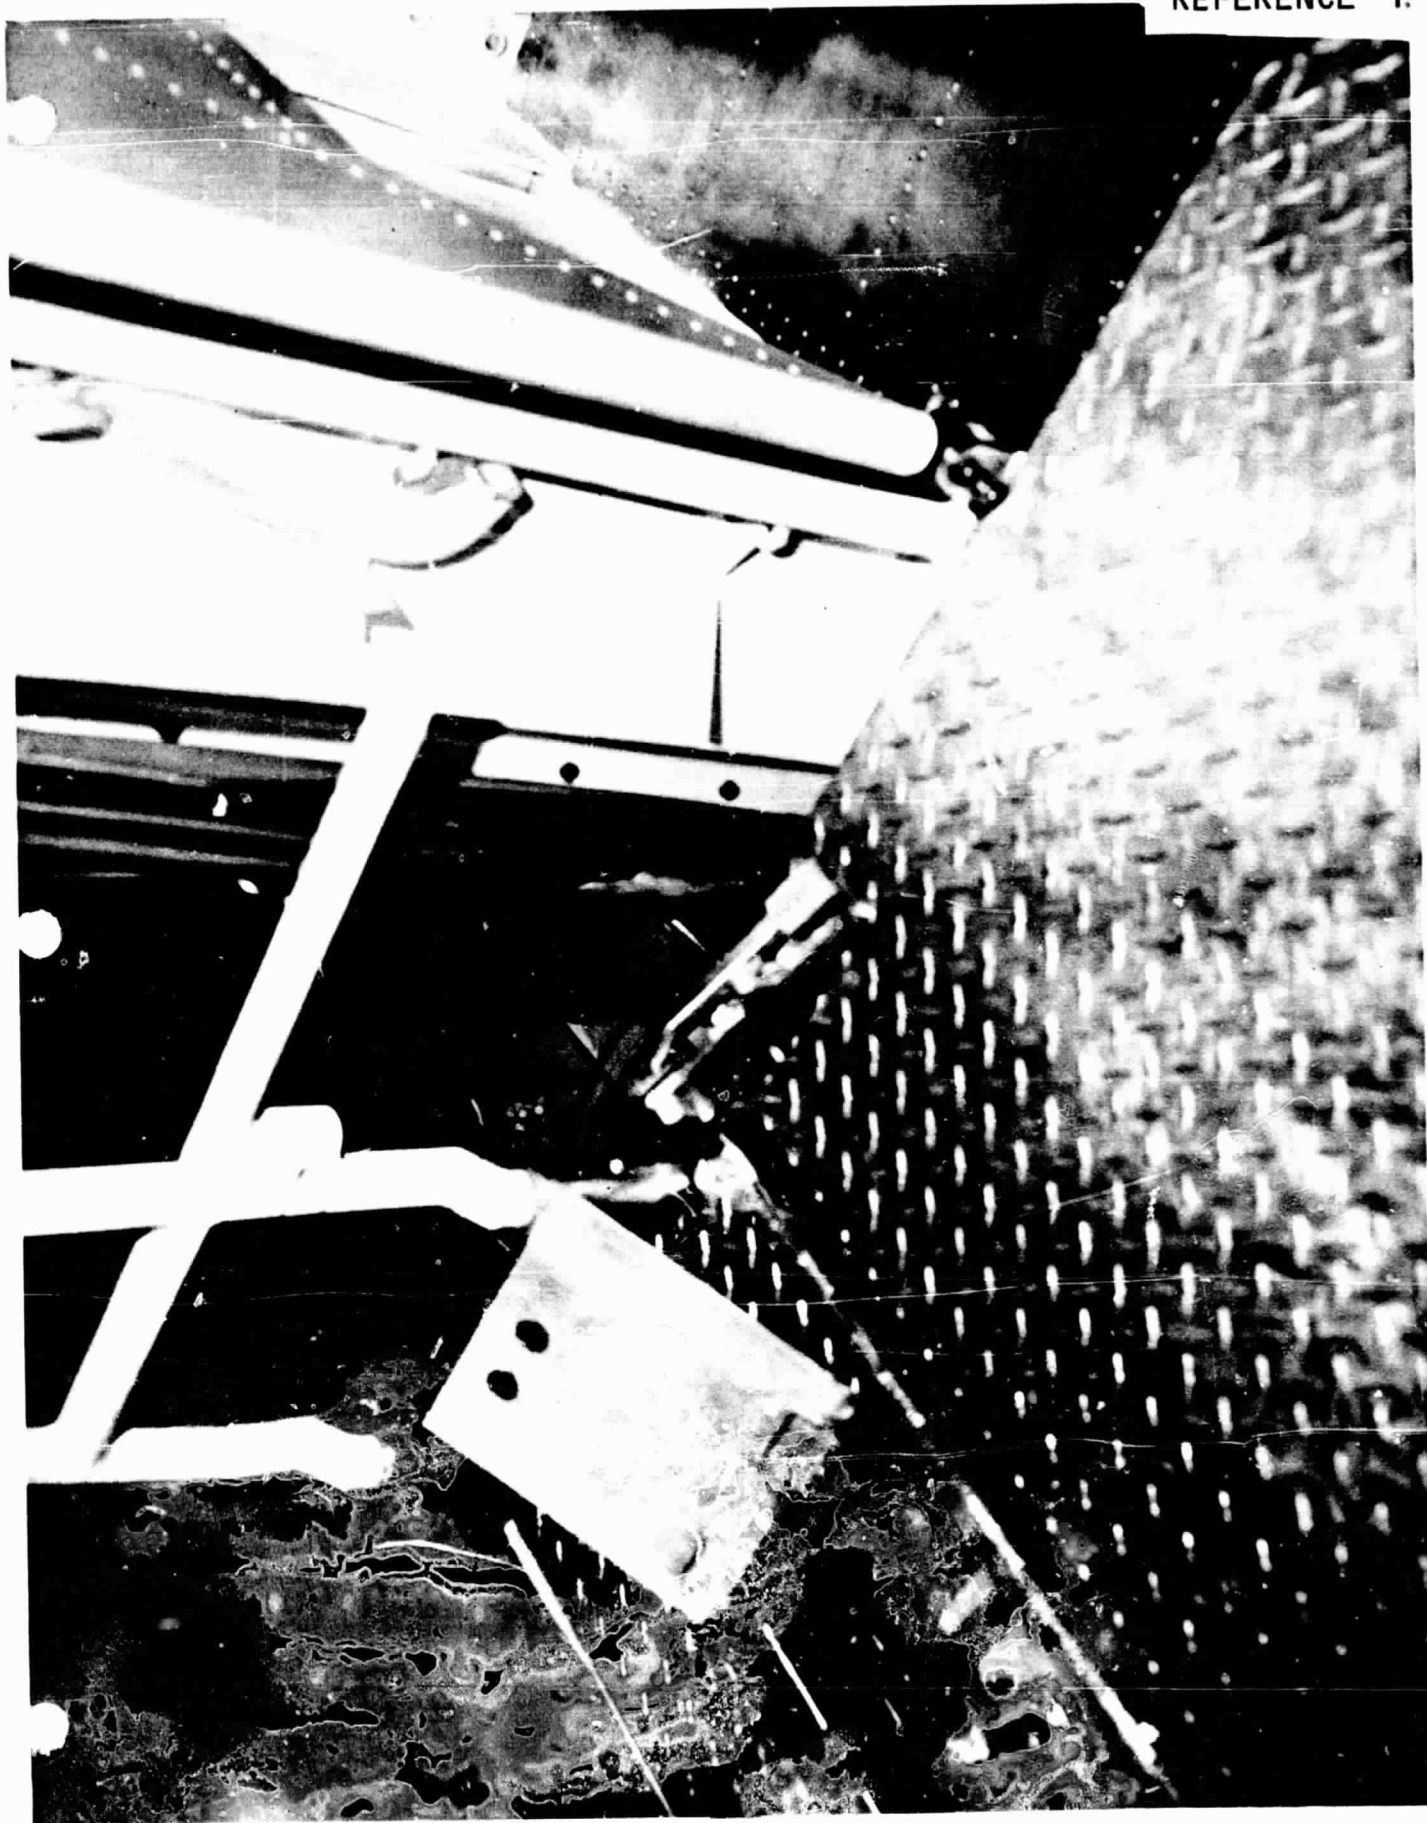
REFERENCE "J"

(6) The modified dock seal was inflated with both blowers and the vehicle simulator was moved through the four points of the tracking envelope. An adequate seal was maintained on the vehicle skin panel when motion occurred toward and away from the chamber opening (Points D and E). Tracking motion to either side of center nominal resulted in excessive folding and bulging of the dock seal fabric. Physical conditions that were observed are shown in References J, K, L, M, N and O.
